PROW Survey Form

Footpath no 21 – page 2

Path 21 - photo record

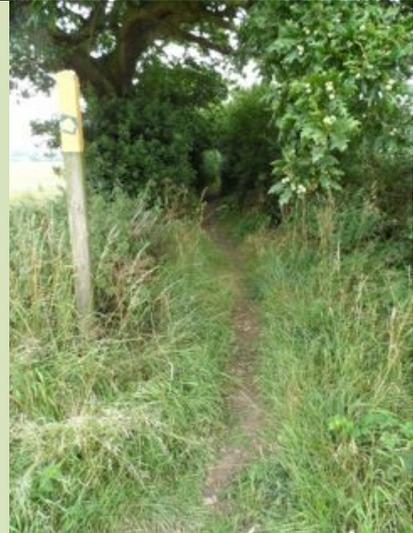
4	M	At the top of this section of the path, the footpath goes to the left, over two footbridges and up an avenue within the hedgerow	This path was cleared recently, by persons unknown, after being impassable for some time. A diversion has been walked along the field edge	The path needs clearing, so that the line is clear and the path is easier to walk, so as to encourage walkers to walk the line of the official footpath	
5	M	The path runsbetween two hedges	The path is narrowed, along part of its length, by overhanging vegetation	The path needs regular maintenance to keep it clear	
6	V	Where the path emerges from between the hedges, it runs along the field edge, to join Path from the disused railway line	The first section is badly overgrown, and a deviation on the field has been walked	Path needs clearing
